### Home Inspection Report

123 Main St., Anytown, IN 00000

Tuesday, June 2, 2015

Brick&Beam Home Inspections LLC

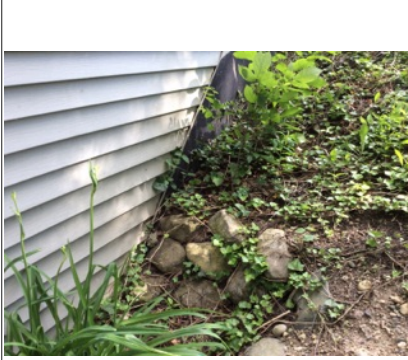
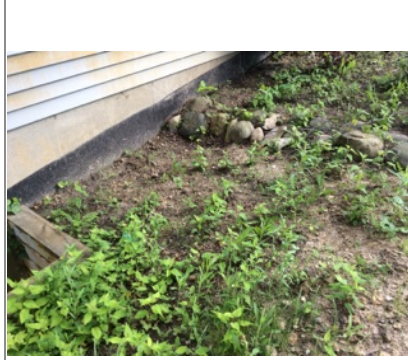
**Negative Grade** ☐ East ☒ West ☐ North ☐ South ☐ Satisfactory ☒ Recommend additional backfill  
☐ Recommend window wells/covers ☐ Trim back trees/shrubberies  
☒ Wood in contact with/improper clearance to soil

**Comments** Recommend maintaining a positive drainage slope away from the foundation. Recommend a clearance of 6-8" from the bottom of the siding to the grading

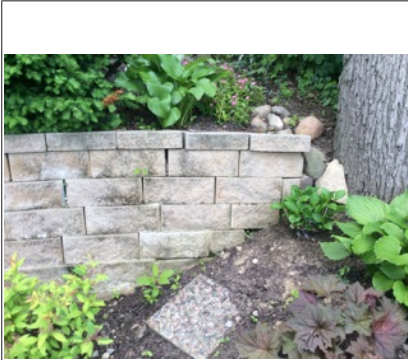
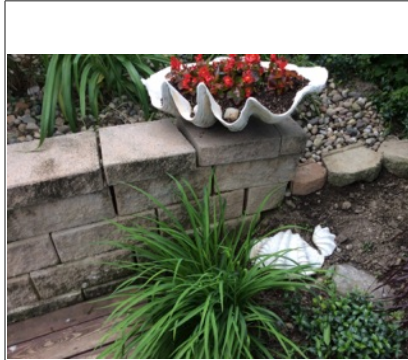
**Material** ☐ Brick ☐ Concrete ☒ Concrete block ☐ Railroad ties ☐ Timbers ☐ Other  
**Condition** ☒ Satisfactory ☐ Marginal ☐ Poor ☐ Safety Hazard ☒ Leaning/cracked/bowed  
☐ Drainage holes recommended

**Comments** Retaining walls were for landscaping purposes only.

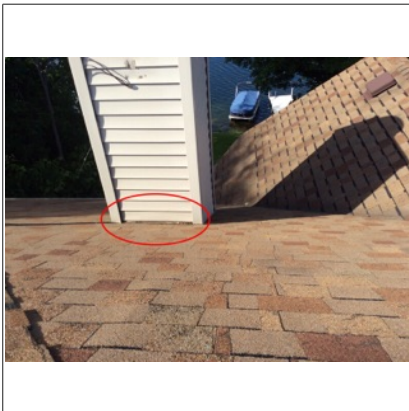
**Comments** Chimney did not have a cricket or saddle on the upper slope. Recommend monitoring for potential leaks.

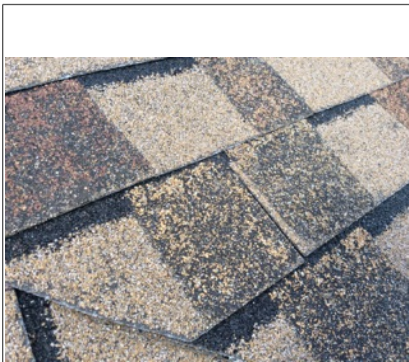
- Roof #1** ☐ Satisfactory ☒ Marginal ☐ Poor ☐ Curling ☐ Cracking ☐ Ponding ☐ Burn Spots  
☐ Broken/Loose Tiles/Shingles ☐ Nail popping ☒ Granules missing ☐ Alligating ☐ Blistering  
☐ Missing Tabs/Shingles/Tiles ☐ Moss buildup ☐ Exposed felt ☐ Cupping

Roof appeared to be nearing end of its useful life, budget to replace soon.

Closeup of shingle showing missing granules.

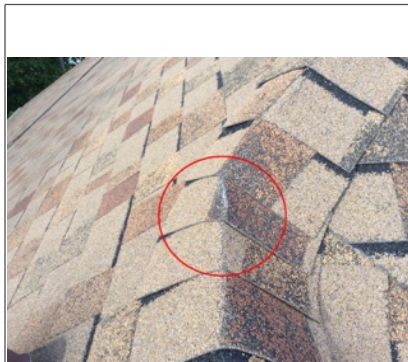
Ridge cap showing missing granules and cracking.

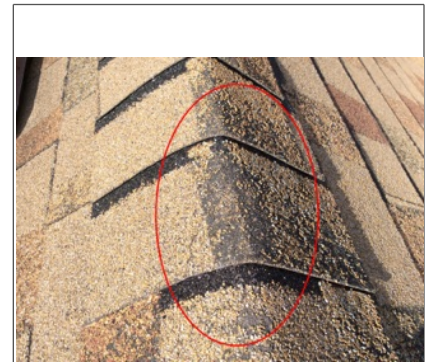
Photo of ridge cap showing significant loss of granules.

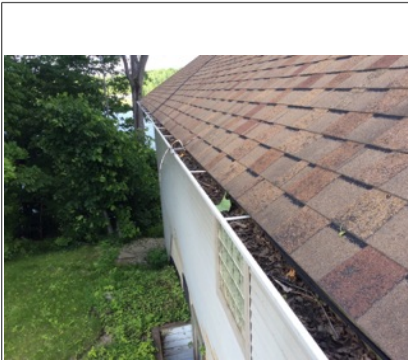
Photo showing debris in gutter.  
Recommend cleaning.

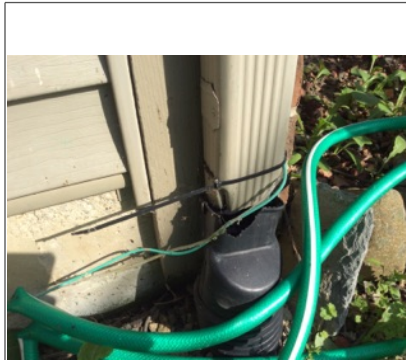
Southwest corner of house  
showing damaged downspout  
adapter.

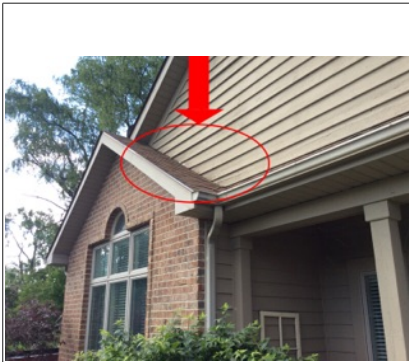
☐ None  
**Material** ☒ Wood ☐ Fiberboard ☒ Aluminum/Steel ☐ Vinyl ☐ Stucco ☐ Recommend repair/painting  
☐ Damaged wood ☐ Other  
**Condition** ☐ Satisfactory ☒ Marginal ☐ Poor  
**Comments** A minimum clearance of 3/4" is recommended between roofing material and siding to prevent moisture wicking. Wood siding is showing signs of deterioration due to contact with roof.

Wood siding showing deterioration.

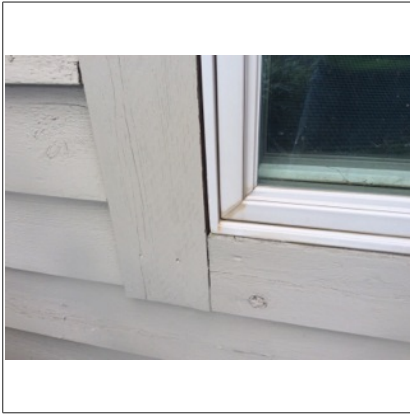
☐ None  
**Condition** ☐ Satisfactory ☒ Marginal ☐ Poor  
☒ Recommend around windows/doors/masonry ledges/corners/utility penetrations  
**Comments** Recommend caulking around windows, doors, corners, utility penetrations.

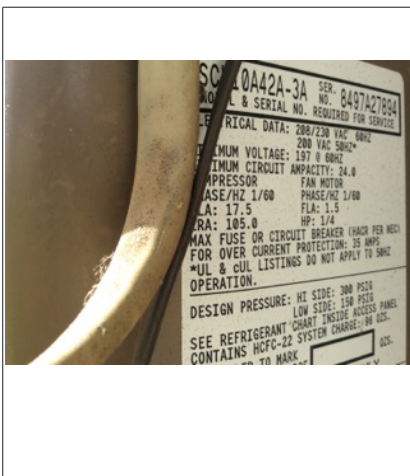
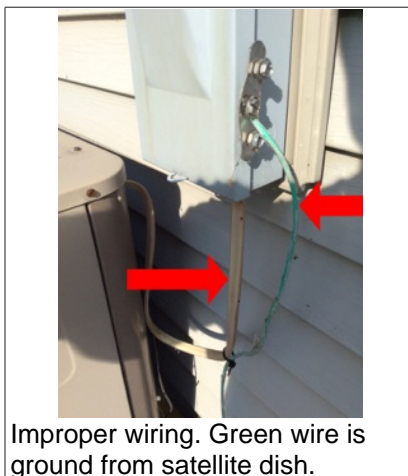
**Comments** Damaged/Missing insulation recommend replacing insulation.  
 Electric line providing power to unit did not appear to be rated for exterior use. Recommend evaluation by licensed electrician.

Improper wiring. Green wire is ground from satellite dish.

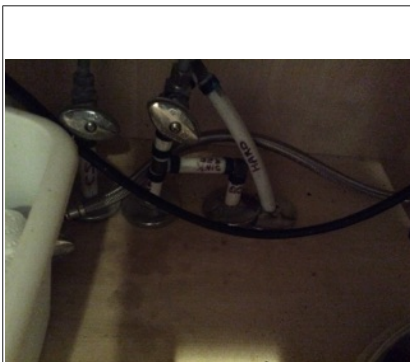
Photo showing moisture damage below sink.

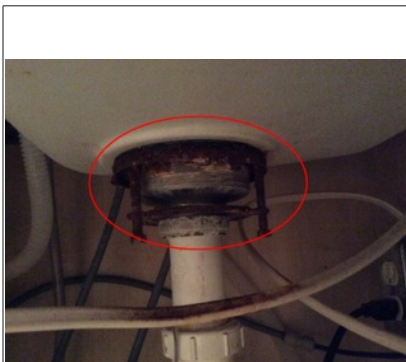
Photo showing corrosion of drain below sink.

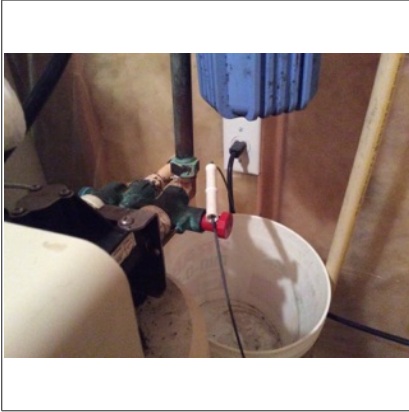
**Comments** Appeared water filter may have leaked in the past.
